Process Safety Beacon Special Issue

Flixborough — In June 2009 it will be 35 Years since the tragedy...

Originally published in June 2004,
Re-issued April 7, 2009

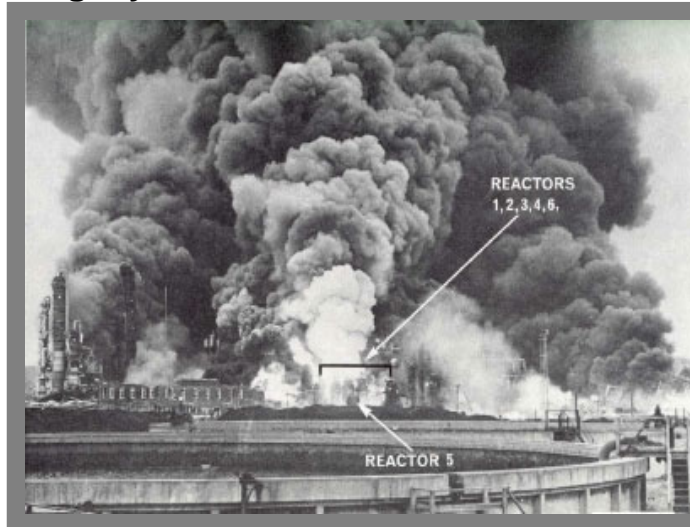
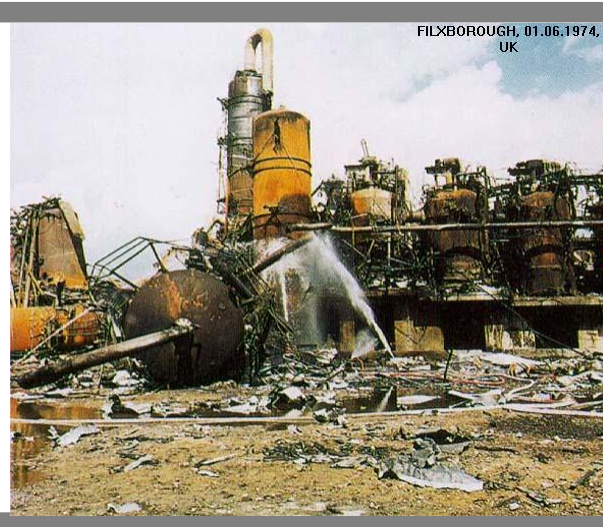
One of the six reactors in series needed repairs. To minimize downtime, it was decided to bypass that one reactor and repair it off line. A temporary bypass line was installed using a pipe with an expansion bellows on each end and supported by scaffolding. Because of the rush to resume production, the new bypass was not tested prior to start up nor were engineering standards or manufacturer's recommendations considered.

Approximately three months later, the expansion bellows in the bypass line failed and released an estimated 30 tons of flammable cyclohexane. The resultant vapor cloud ignited killing 28 people and injuring 89 more. The entire plant was destroyed and hundreds of homes and stores were damaged.

The temporary modification was not adequately reviewed for potential adverse consequences!

- ☛ The temporary bypass was made with two bends in it because the nozzles on the two tanks were at different levels. The impact of internal forces and flow stresses were not considered on the expansion bellows.
- ☛ Expansion bellows were left in place on each end of the bypass line. The suitability of this design and manufacturer's recommendations were not considered.
- ☛ The weight of the temporary bypass was not securely supported—it was simply placed on scaffolding. The amount of movement and the effect of that movement on the bellows were not considered.

- Always follow your company's Management of Change (MOC) procedure. *Remember, temporary changes demand the same rigorous review as do permanent changes.* If you do not utilize a MOC procedure, discuss the value it could provide to your facility.
- Make changes only after thorough hazard reviews have been conducted and approved by qualified experts.
- Use good engineering practices and manufacturer's recommendations.
