Occurrence of metal dusting – referring to failure cases

H. J. Grabke* and M. Spiegel

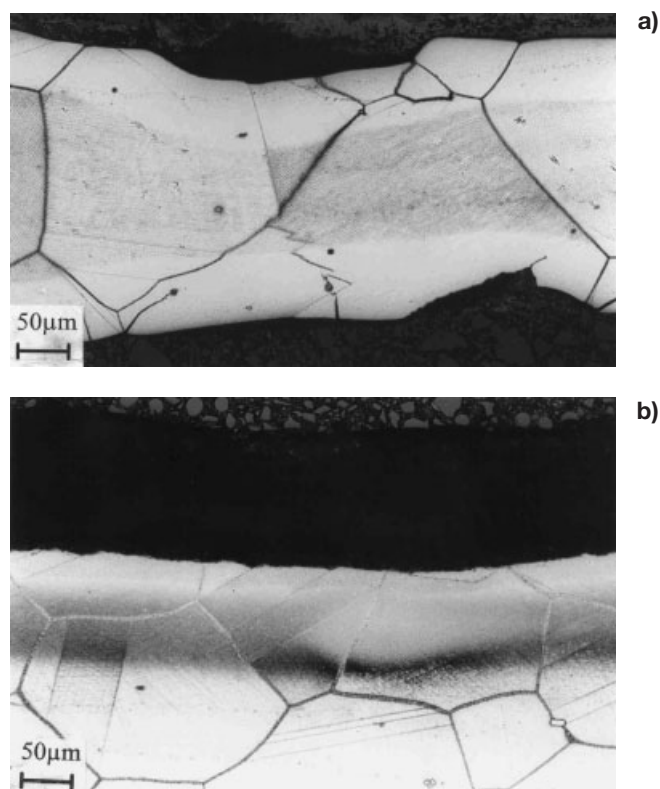
The heat exchanger, built mainly of Alloy 800 failed after 23 000 hours by local thorough wastage of the 10 mm thick sheet. The hole was closed by welding a patch of Alloy 601 on the wall, but after 31 000 hours the heat exchanger was taken out of service. Metallographic cross sections of the wall material indicate nearly uniform metal wastage all over the surface. Fig. 1 a shows a piece of Alloy 800 which was attacked from both sides, and is still covered with some coke but without the typical carburized zone. On Fig. 1 b of a wall section from another place, both carburized zone and coke are visible, the grain boundaries are marked by carbon ingress. A weldment in the wall attacked from both sides shows metal dusting of the base material Alloy 800 and a somewhat slower attack of the Ni-base weld material (\sim Alloy 600), see Fig. 2 a, b.

Since the wall of Alloy 800 was wasted from 10 mm to 3–0 mm in different places, a metal wastage rate results of 2–3 mm/year. Such rates were measured in laboratory tests on Alloy 800 and other steels in the temperature range $525\text{--}550\text{ }^{\circ}\text{C}$ [21, 22]. Since the heat exchanger operated in the temperature range $575\text{ }^{\circ}\text{C}$ to $350\text{ }^{\circ}\text{C}$, one can conclude that the walls made of Alloy 800 were attacked from the begin of operation. The large grained material is very susceptible to metal

Fig. 1. Metal dusting attack on the wall of a heat exchanger, made of large grained Alloy 800, metallographic cross sections; a) wall segment, thinned from both sides from 10 mm to 2–3 mm, b) uniformly attacked wall surface, typical appearance of metal dusting: coke layer, carburized zone

dusting and has no chance to form a Cr-rich protective scale at the relatively low temperatures, due to insufficient Cr-diffusion and –supply to the surface [16–18]. In contrast, some small metal parts which had been in the same heat exchanger, exposed to the same atmosphere and temperature range, showed no sign of metal dusting attack, see Fig. 3 a, b. Both were made of fine grained steels with about the same Cr-content, a nut made of a 21Cr-12Ni-0.7Si-steel, and a stainless steel sheet of 17Cr-9Ni-0.5Si-0.33Ti steel. Both materials had formed a protective oxide scale, the stainless steel in the temperature range 460–550 °C. For both steels the fine grained microstructure was of importance for the oxide formation, providing many fast diffusion paths for transport of Cr and Si to the surface. The analysis of the oxide scales showed a high content of Si at the outer surface, so presumably the relatively high Si-content of the steels led to an initial SiO_2 -formation and was helpful in formation of a protective dense scale which prohibited carbon ingress and start of metal dusting.

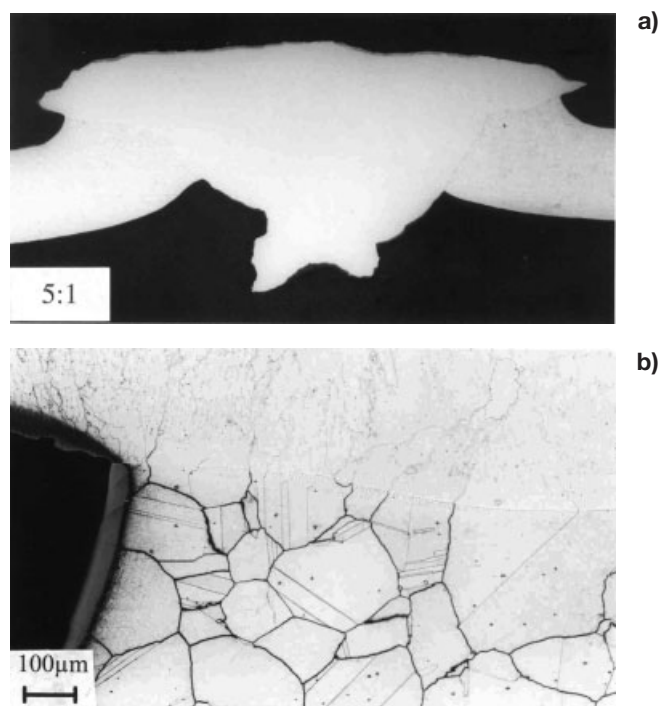
Fig. 2. Metal dusting attack on a weldment in the wall of the same heat exchanger, metallographic cross sections: a) total view, weld material less attacked than the base material (unetched), b) corner of the weldment, showing carburized zone in the weld and base material

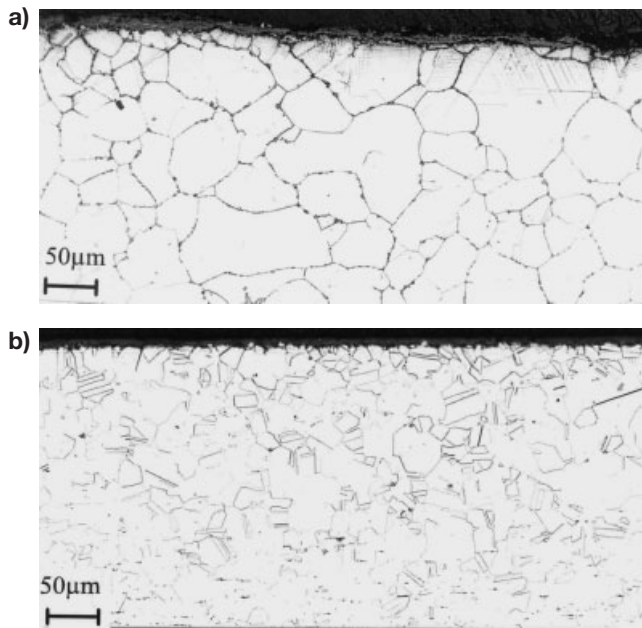
Fig. 3. Metallographic cross sections of parts from the same heat exchanger (see Figs. 1 and 2), not attacked by metal dusting but covered with a protective scale, parts made of fine grained materials: a) 21Cr-12Ni-0.7 Si steel, b) 17Cr-9Ni-0.5Si-0.33Ti steel

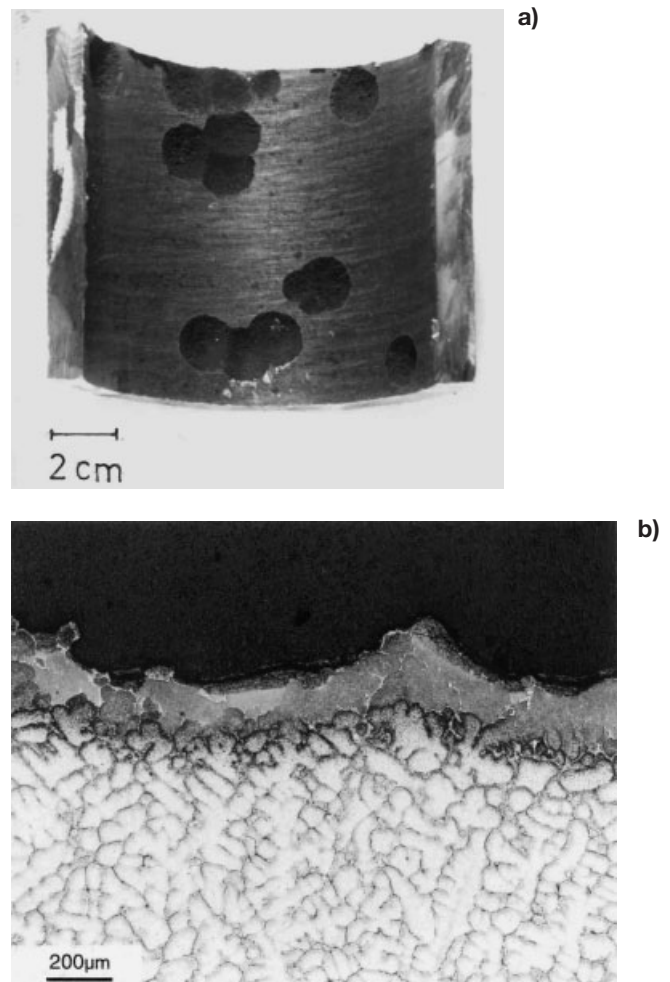
A strong attack by metal dusting was investigated in detail [23] which had occurred in the gas heaters of a direct reduction plant, where a H_2 -CO-CO₂-H₂O mixture is heated from ambient temperature to reduction temperature, about 950 °C. The heater coils had been produced from centrifugally cast tubes of the steel HK 40. This steel has the nominal composition 25 Cr-20 Ni-1.2 Si, but in the case described the Cr-content was at the lower level 22–23% Cr which was one reason of the failure. The material has a coarse dendritic microstructure with large carbide precipitates (M_{23}C_6). At elevated temperature the steel tends to ageing by precipitation of fine secondary carbides and σ -phase. The inner walls of the straight

Fig. 4. Metal dusting attack in the heater tube of a direct reduction plant at about 600 °C; a) tube section of HK40 (cast 25%Cr-20%Ni steel) with deep pits, b) metallographic cross section, showing pits and carburized zone

tube segments are machined, the cast surface with its pores is removed and additionally a certain surface-near deformation is introduced. The heaters are operated usually under introduction of sulfur, by dosing DMDS, $(\text{CH}_3)_2\text{S}_2$ which should decompose at process temperature yielding a sufficient level of H_2S for protection. A constructional error in the plant caused that for some time one of the heaters was not supplied with DMDS. Short time after, leaks occurred and strong metal dusting attack was detected in wide regions of the coils. Depending on the temperature more or less deep pits were found in the inner wall of the tubes, see Fig. 4 a, b. The welds or the heat affected zones near the weld, were attacked even stronger than the straight machined sections. Since heaters of this type are used generally without severe failures for many years, when sulfur is supplied continuously, the lack of H_2S in the atmosphere obviously was the main reason of this failure. Additionally, the low Cr-content of the steel was a weakness, and the microstructure and composition of the welded joints caused enhanced attack.

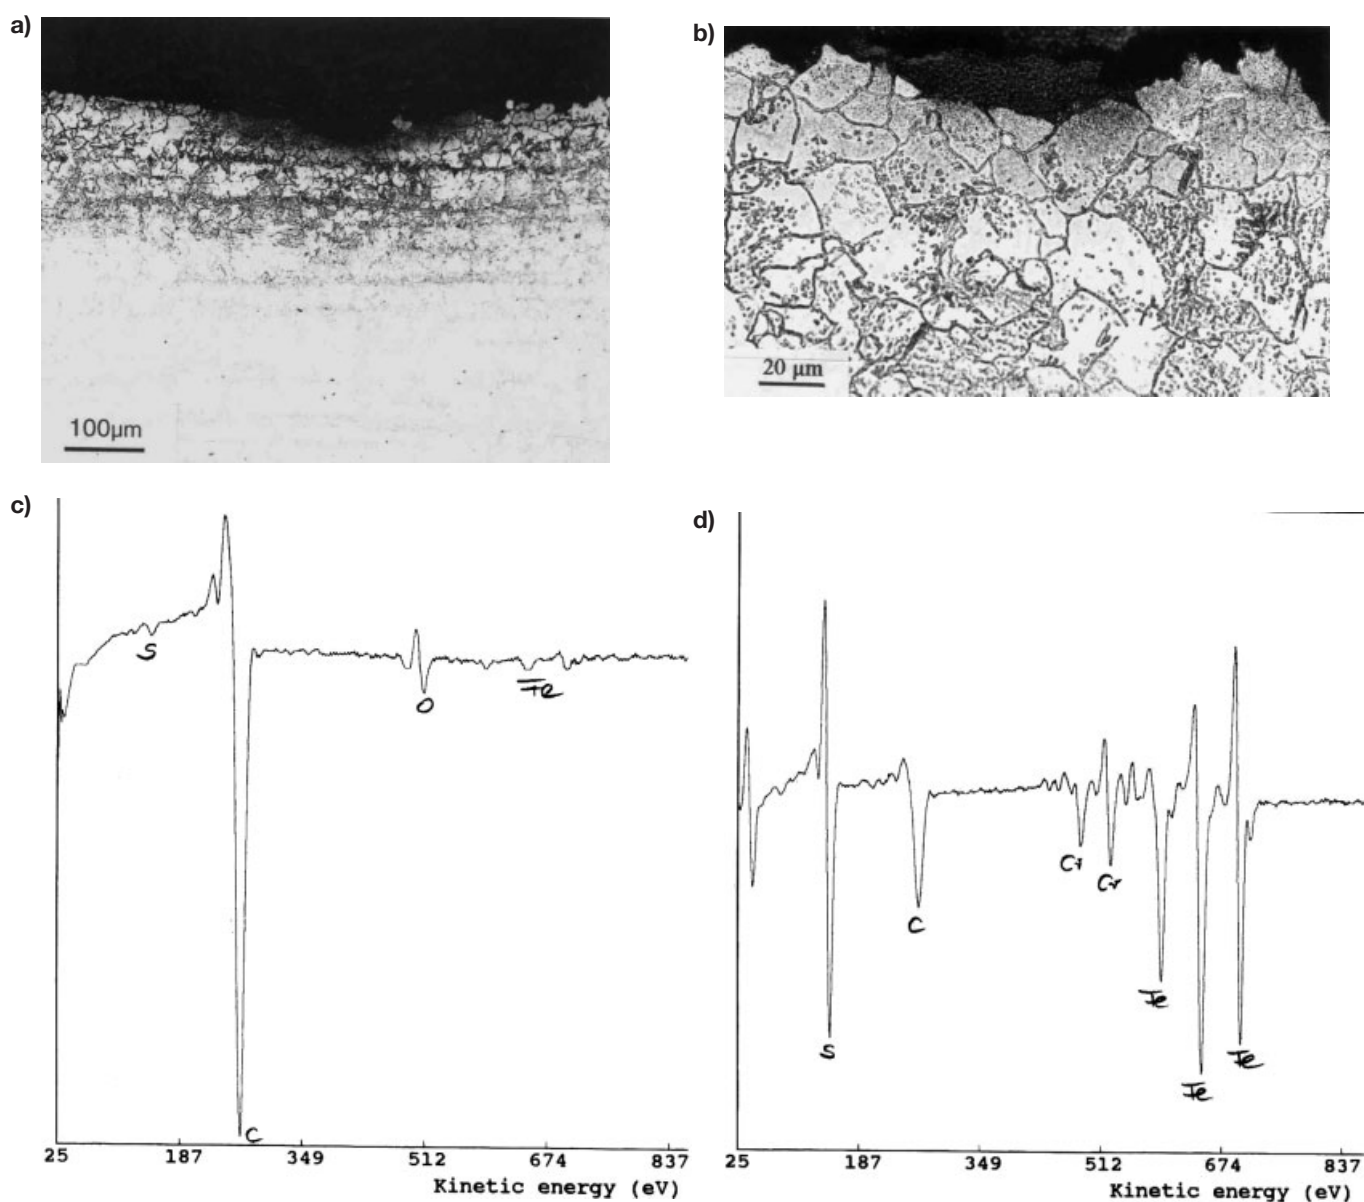
By analyses of intact old tubes from the same CCR unit, hints were found to explain why the pipes installed earlier did not fail. The metallographic cross section shows an internally carburized zone and a scarred surface, see Fig. 5 a, b, i.e. indications of metal dusting. Auger-spectra taken on the surface showed graphitic deposits or metallic areas covered with adsorbed sulfur, see Fig. 5 c, d. Obviously the material had been largely protected by adsorbed sulfur and a coke layer, and only very slow metal dusting had taken place. In contrast, the new tube had no chance to obtain such protective coating, due to the enhanced operation temperature and the insufficient level of sulfur in the atmosphere.

Fig. 5. Metal dusting of the inner tube wall in a refinery heater (CCR unit); a) and b) metallographic cross sections, showing only moderate attack of the 5%Cr-steel, c) and d) Auger spectra demonstrating the protecting carbon and sulfur layer on the surface

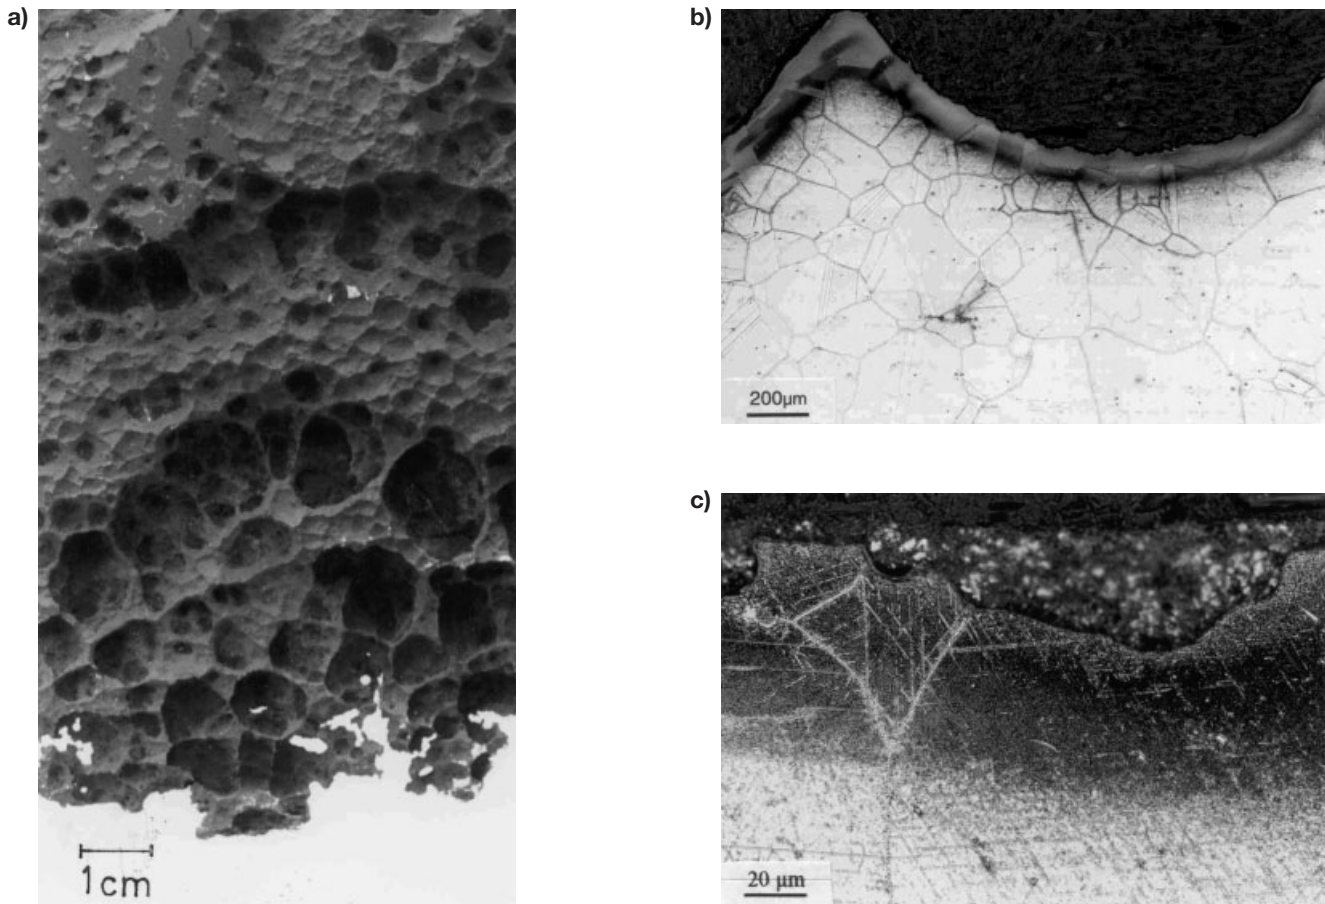
Fig. 6. Severe metal dusting attack on a steel sheet (Alloy 800) from a direct reduction furnace; a) piece of the steel sheet with vast erratic pitting, b) and c) metallographic cross sections, showing pits with carburized zone and coke

In this case, sheets of Alloy 800 suffered a very strong attack (see Fig. 6 a, b, c) within about 6 month, after 20 years operation with only minor attack. These sheets serve for guiding the cooling gas from the lower part of the shaft furnace into the upper part, where the reduction gas enters. The ore is reduced on its way from the top of the furnace and leaves as iron sponge at its bottom. In the region in question the temperature is 400–500 °C and the H_2 -CO-CO₂-H₂O atmosphere has carbon activities between $a_C = 2000$ to 100. The material Alloy 800 is rather susceptible, but the sulfur content ~ 10–12 ppm H₂S should effectively retard the metal dusting attack so that the 20–25 mm thick sheet could serve for many years. Some additional attack must have caused the acceleration. EDS analysis of the corrosion products indicated presence of chlorides, and it was known that chlorine had been introduced in the process line for controlling the growth of algae in a cooling unit. Obviously the presence of chlorine and the formation of chlorides hindered the formation of protective oxide scale and the very severe attack is due to the combined action of chloridation and metal dusting.

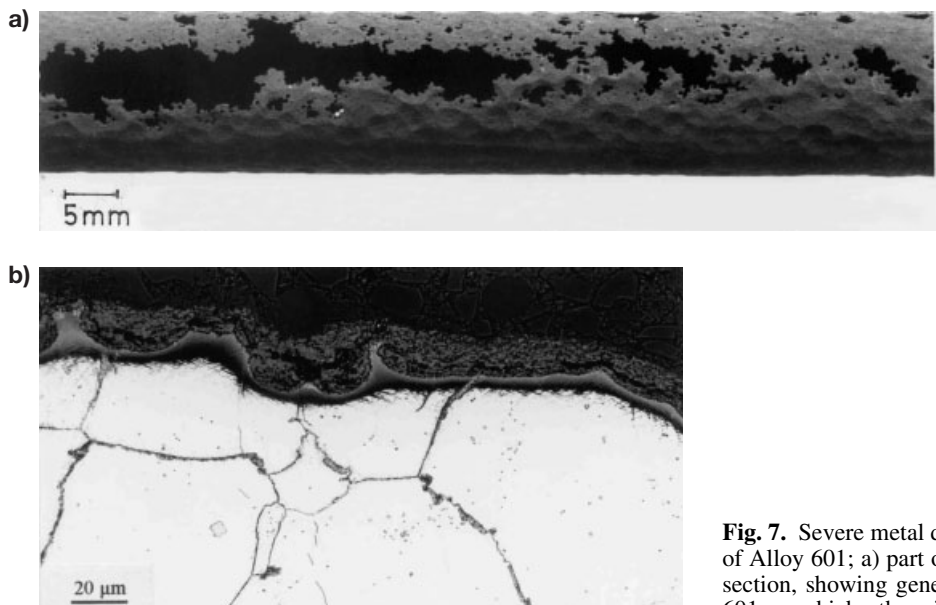
A tube section which had been in service for 2¼ years was received for failure analysis, it showed severe attack by metal dusting on the outer surface (Fig. 7 a, b) and locally some greenish spots. These spots were deposits of mineral salts, as shown by EDS and AES analysis and most probably stemmed from an ingress of steam at the gas side, ½ year before the failure and inspection. In addition to the alloying elements the analyses detected: K, Na, Mg, Ca, Cl and S, which should not be carried by the process gas and should not be present on the tube. It may be concluded that deposition of mineral salts from the impure steam on the tube has locally destroyed the protective oxide layer on the Alloy 601. Preliminary tests on the effect of salt deposits, chlorides, sulfates and carbonates have shown accelerated start and enhanced attack by metal dusting on several materials.

Fig. 7. Severe metal dusting attack on a heat exchanger tube made of Alloy 601; a) part of the corroded tube, b) metallographic cross section, showing general metal dusting – quite unusual for Alloy 601 on which otherwise single hemispherical pits occur
