## **Carburization and Metal Dusting in Fired Heaters and Steam Methane Reformers: Plant Integrity Issues**

A. R. Franks, S. L. Bagnall

Key words: carburization, metal dusting, fired heater, steam methane reformer, life assessment, TOFD

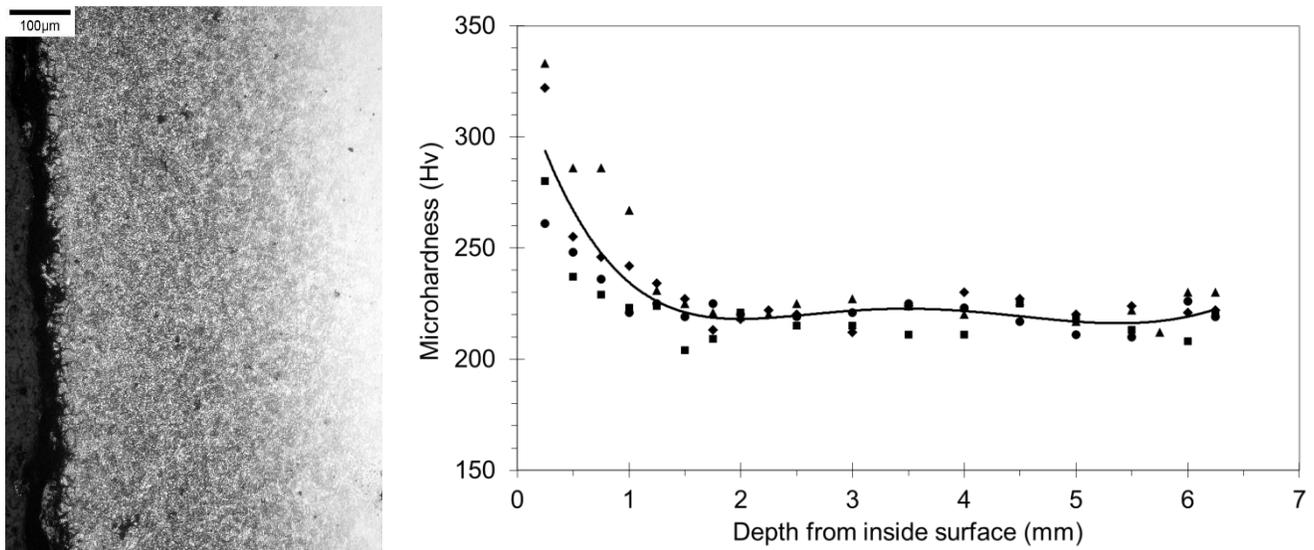
Figure 2: Etched section and hardness profile through the carburized layer in a 9CrMo tube

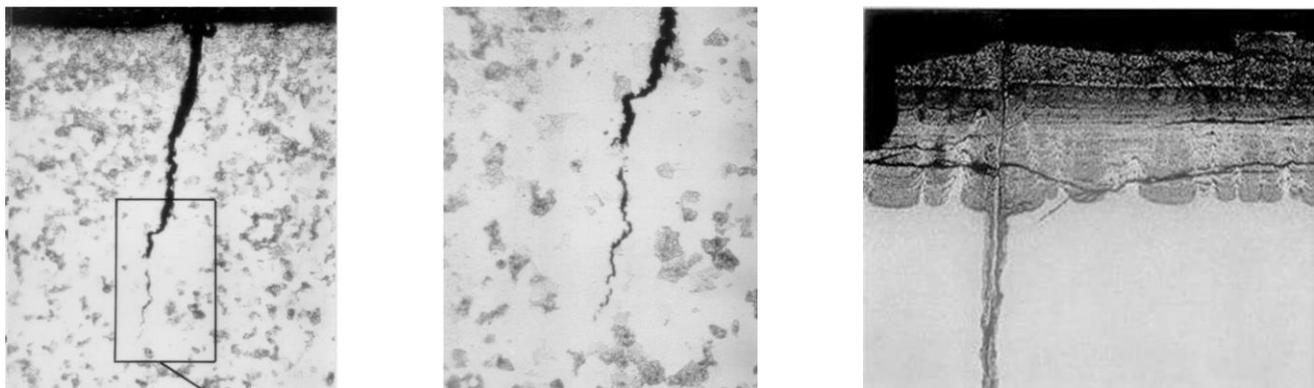
(a, b) progressive cracking of the carburized zone

(c) spalling

Figure 3: Crack development through the carburized layer in 9CrMo tubes

There is a volume expansion associated with carbon take-up, leading to local stresses, but at moderate carburization rates these redistribute, by creep, to low levels and the gross distortions seen in steam cracker tubes do not occur in fired heater or SMR tubes. As Grabke<sup>1</sup> points out, carburization leads to a deterioration in low temperature ductility and toughness, also to an increase in high temperature creep and tensile strength. However, the drop in high temperature ductility must not be underestimated. At moderate thicknesses the carburized layer can through-crack, most likely on plant shut-down due to stresses induced by the difference in thermal expansion between carburized and unaffected material (Figure 3a, crack depth ~ 1.5 mm). This cracking appears to progress step-wise (Figure 3b). Eventually spalling of the carburized layer occurs (Figure 3c, spalled thickness ~1 mm).

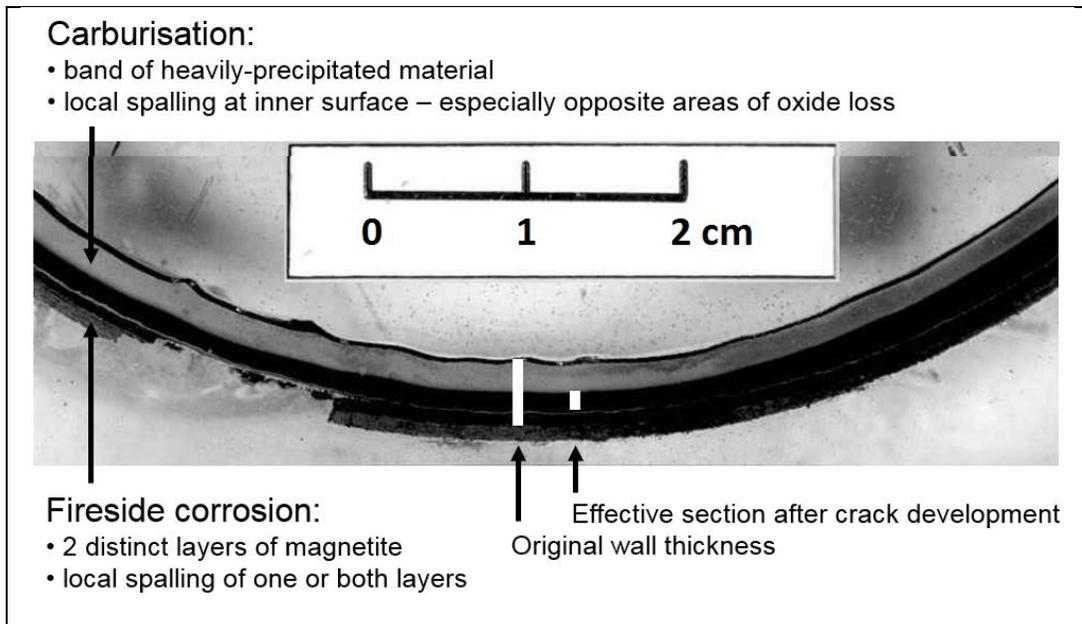
**Figure 4: Through-wall section of a 9CrMo CCR heater tube**

Figure 4 shows the relevant features of a 9CrMo continuous catalytic reformer (CCR) heater tube subject to fireside oxidation and internal carburization. The light-etching band, extending to around half the remaining tube wall thickness and corresponding to the carburized zone, is clear. At this magnification the cracking is not visible, but this tube is from the same heater as those shown in Figure 3 and cracks are present. Evidence of the associated spalling is visible. At the outer surface the double magnetite

layer produced by fireside corrosion is seen, the interface between the layers corresponding to the original metal surface. Local spalling of one or both layers is evident. The white bars denote the original wall thickness and the current effective load-bearing section. In combination, therefore, carburization and fireside corrosion can lead to losses in section and corresponding increases in stress that greatly accelerate creep life consumption.

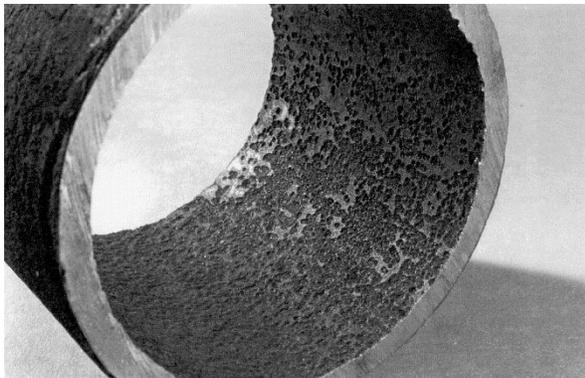
Metal dusting can manifest in several ways, as seen in Figure 5. Pitting, either widespread or local, is common as seen in the 5CrMo heater tube shown in Figure 5a.<sup>5</sup> Areas of enhanced heat flux provide preferential sites, as evidenced by the leak at the thermocouple installation on the 9CrMo CCR tube shown in Figure 5b (courtesy UOP). In certain instances a pit can develop preferentially, leading to penetration of the tube wall as seen in the 5CrMo crude heater tube shown in Figure 5c. The volume expansion associated with dust formation is seen to lead to a general out-of-roundness and a local extrusion of tube metal forward of the growing pit. The light-etching halo of carburized material surrounding the pit is also evident in this photograph. In the extreme, melting of the tube can occur, Figure 5d. This is associated with the fall in solidus temperature associated with high carbon levels and overheating effects where the 'dust' remains adherent to the tube wall.

(a) General pitting

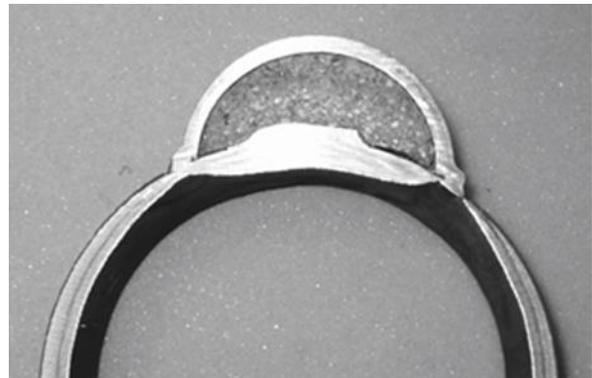
(b) Local thinning at a hot-spot

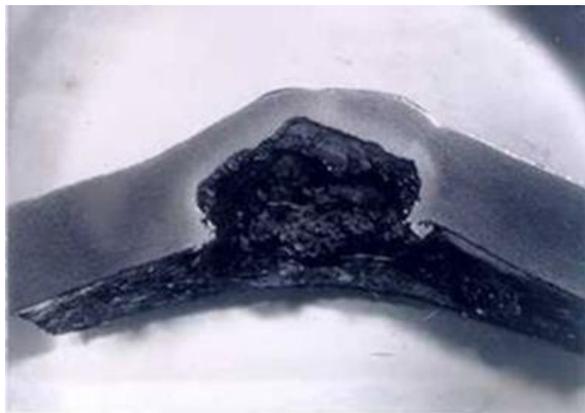
(c) Preferential development of a single pit

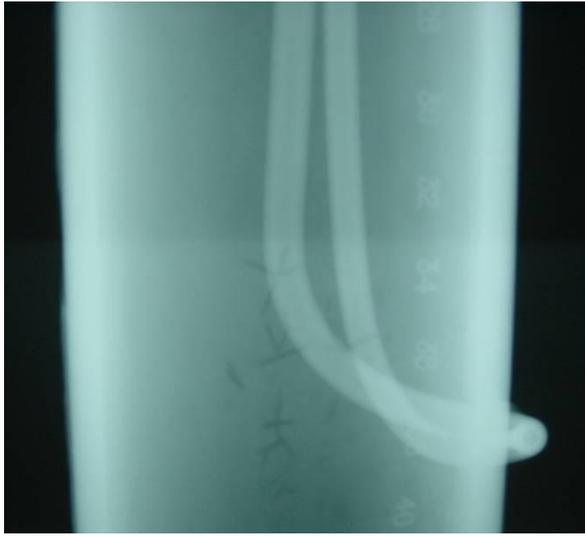
(a) Radiographic image

Radiography, performed after a tube leak, revealed characteristic but unrecognized features, resembling a bird's footprints, (Figure 6a). A video-camera inspection showed that these were cracks with unusual raised edges, associated with the pitting typical of metal dusting (Figure 6b). The photograph of a sectioned tube (Figure 6c) shows the morphology more clearly. A metallographic section (Figure 6d) elucidates the mechanism. A general, and deep, carburized layer is apparent, with a wide crack extending to around half its depth. This crack was tightly packed with typical dust. The associated volume expansion had widened the crack and forced tube metal to the surface, creating the raised edges to the cracks. A narrow crack extends a further 1.5 mm into the material and, as it provides a rapid diffusion path for carbon, the carburized zone is seen to be further developed local to the crack than elsewhere. This progressive cracking resembles that seen in Figure 3 and suggests the following sequence of events, which was confirmed by retrospective re-examination of samples taken at a previous outage. For some time, the tubes operated under circumstances where carburization occurred, but not metal dusting. The normal increase in carburization depth and progressive cracking took place. Later, changes in operation, discussed below, rendered the tubes susceptible to metal dusting. At the surface this produced the usual pitting, seen in Figure 6b – but it also took place within the existing cracks, leading

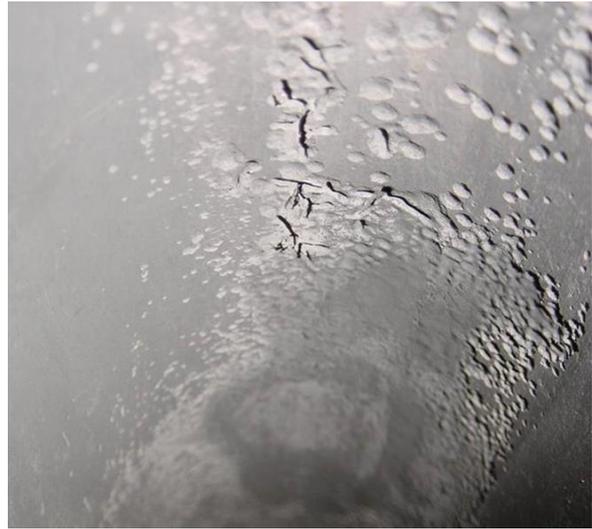
(b) Video-camera image

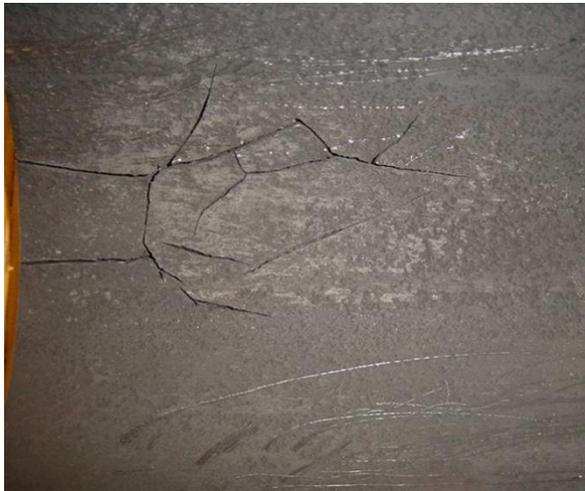
(c) Macro-photograph

to the crow's foot mode of development as the cracks filled with the metal dust and were forcibly widened. The random direction of the cracks reflects the bi-axiality of the thermal stresses that lead to their formation.

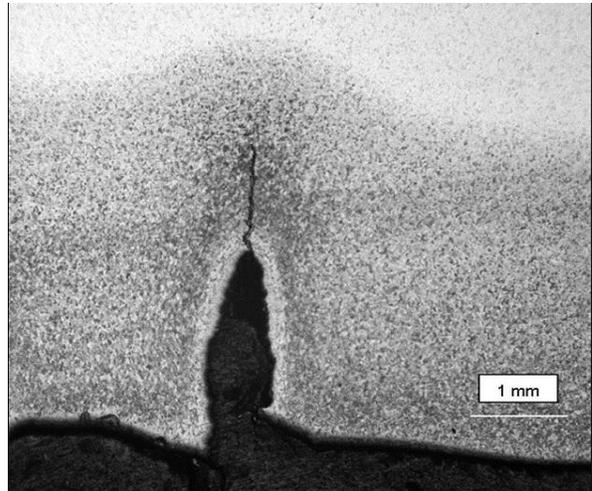
(d) Metallographic section

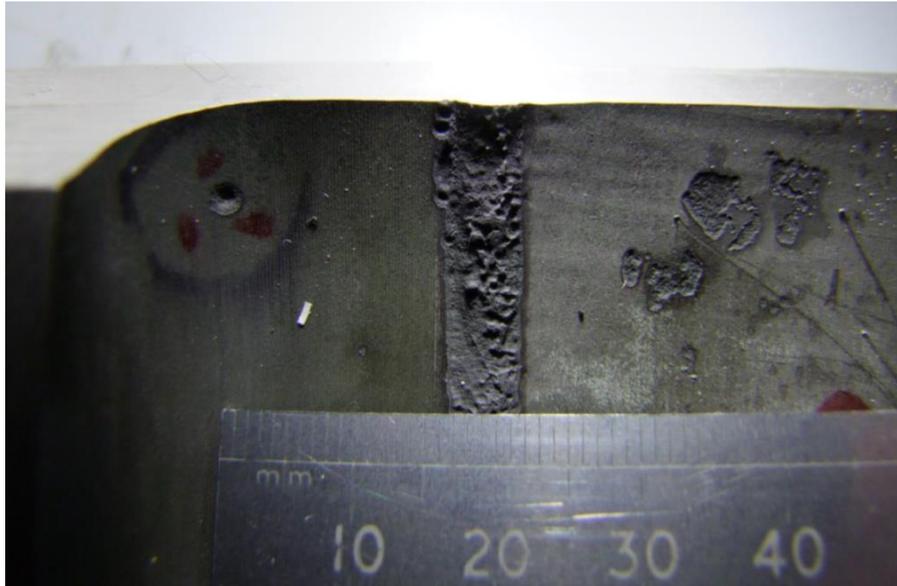
This example concerns the SMR mentioned in the context of Figure 1. A side-fired unit, it contains a single row of 45 tubes, directly connected to the cold-shell outlet manifold. Present tube metallurgy is an HP-Nb micro-alloy (25Cr35NiNbTi). During investigation of a leak that transpired to be a manufacturing defect, evidence of metal dusting was observed in the static casting that formed the outlet of Tube 44. Figure 10 shows a macro-section of this static casting (left) welded to the centricast tube (right). Pitting is seen on both casting and tube and, more extensively, on the weld.

**Figure 10: Evidence of carburization and metal dusting in SMR Tube 44 outlet section**

By contrast, Tubes 43, 44 shown in Figures 10 and 11 are from the area where the lowest recorded temperatures occur. Given that the temperatures shown in Figure 12 come from within the firebox, but the tube outlets are located beneath the furnace floor and see no radiant heat, it is quite possible that the tube outlets come – at least intermittently – into the temperature range where metal dusting is possible. This would be rendered more likely if there is flow stagnation below the catalyst support basket which sits in the outlet casing or if there are any draughts below or through the furnace floor.

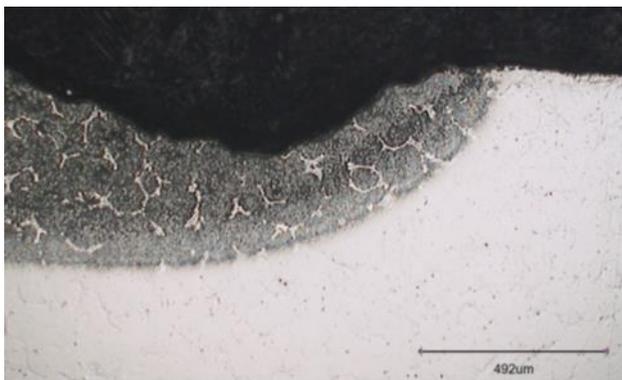
Figure 11 shows metallographic sections of the pitted areas in the casting (left) and weld (right) of neighboring Tube 43; the field of view is approximately 1.5mm in each case. In both materials, a clear carburized zone is apparent surrounding the pits. The carburized zone in the weld metal contains numerous voids, evidence of the early stage of metal dusting.

(a) Outlet casting

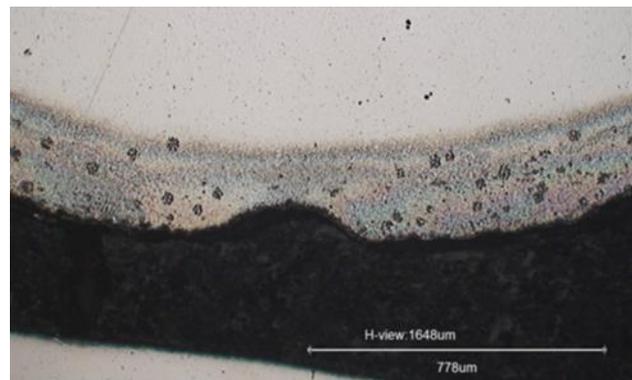
(b) Weld metal
