## **Carburization and Metal Dusting in Fired Heaters and Steam Methane Reformers: Plant Integrity Issues**

A. R. Franks, S. L. Bagnall

Key words: carburization, metal dusting, fired heater, steam methane reformer, life assessment, TOFD

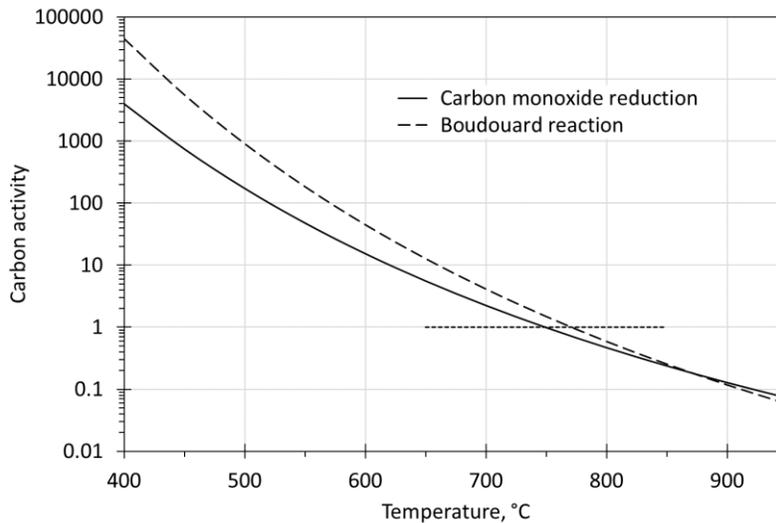
**Figure 1: Relation between carbon activity and temperature for a steam methane reformer**

A practical illustration of Equations 2, 3 is given in Figure 1. This pertains to a specific SMR with partial pressures at the catalyst tube outlet of:  $[CO] = 3.5$ ,  $[CO_2] = 2.9$ ,  $[H_2] = [H_2O] = 6.5$  bar. As will be discussed later, certain tubes in this reformer, which serves a combined refinery and petrochemical complex, are subject to carburization and metal dusting. The carbon activity reaches unity at around 775°C.

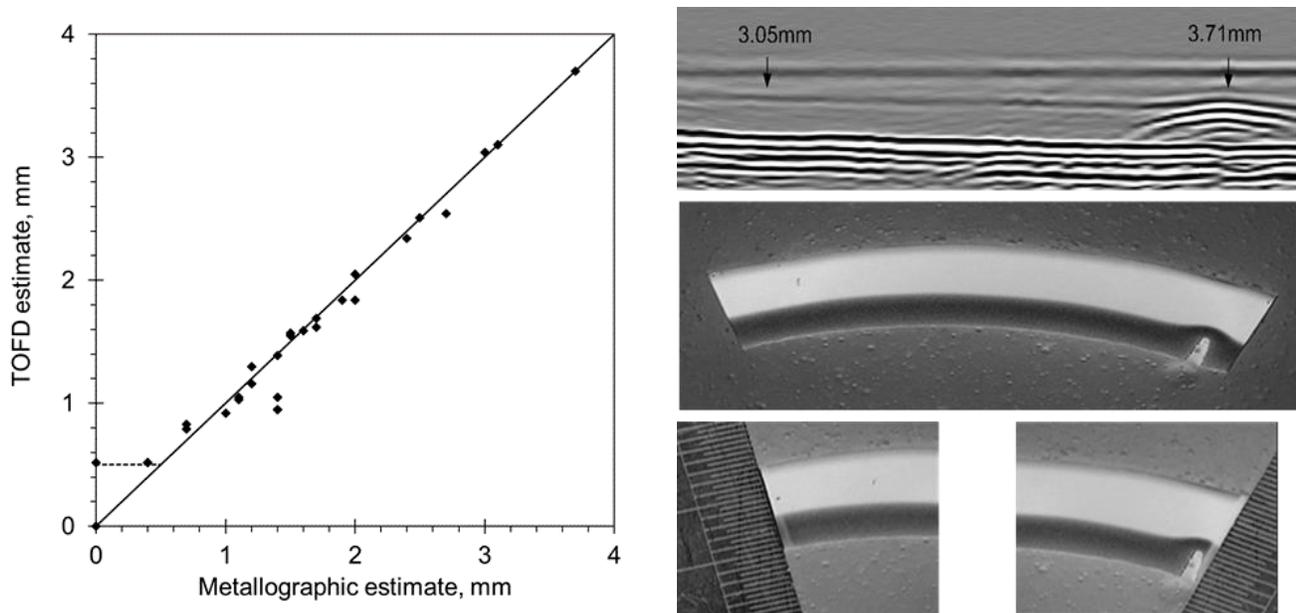
As a result of the authors' work on the above CCR problems, there is now an established non-destructive inspection technique, based on ultrasonic time-of-flight-diffraction (TOFD),<sup>9</sup> which can measure the depth of carburization without the need to remove samples. The inspection protocol and set-up parameters are critical to the ability of this technique to locate and identify carburization damage, as it is possible to carry out a standard TOFD inspection and not identify any carburization present. Figure 7 shows examples of the work done by the authors to validate this technique. The graph compares measurements of carburized zone depth obtained by TOFD with those obtained by destructive metallography. It indicates a resolution limit at around 0.5mm and an excellent correlation above 1.5mm. The photographs show the TOFD scan (top) of an area containing both uniform carburization and a crow's foot crack (centre). Clear resolution of both phenomena is apparent and the accuracy of the depth measurements, crudely demonstrated by means of a ruler (bottom), was very high – the crow's foot crack contributing the highest point to the graph at the left.

**Figure 7: Validation of the TOFD technique for carburization, left, and crow's feet, right**

Confidence in the technique for detecting and measuring carburization is high. Metal dusting, as its occurrence is often localized, can be more problematic to detect, but when detected, measurement accuracy is good. The technique also determines the tube wall thickness.

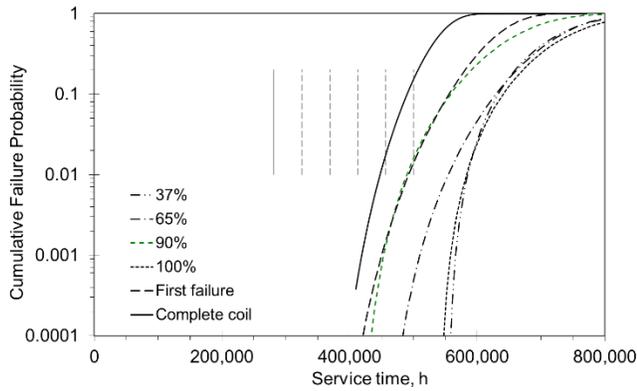
(a) Predicted failure probability

Figure 8 summarizes the results for the lead coil. Predicted failure probability curves are shown in Figure 8a. Curves are given for each tube where skin temperature data are available, designated by the position of the sensor along the total coil length. The shortest predicted life occurs at the 90% position, which fact immediately allows some focusing of future inspections. The longest predicted lives occur at the 37% and 100% (outlet) positions. A further curve shows the distribution of first-failure times, independent of position. Unsurprisingly in this case, it broadly follows the curve for the lead position, at 90% of coil length. While these results show the most critical positions in the furnace, and the lives associated with them, for planning purposes it is useful to integrate these probability curves over the complete tube set and obtain a failure probability curve for the coil as a whole. Comparing this curve with the vertical lines on the graph, which denote the present time and each of the planned 5-year operating campaigns, it is seen that operation for two further campaigns is well within the coil's capacity, but a third might be marginal. A re-run of the assessment at the next turnaround will clarify this.

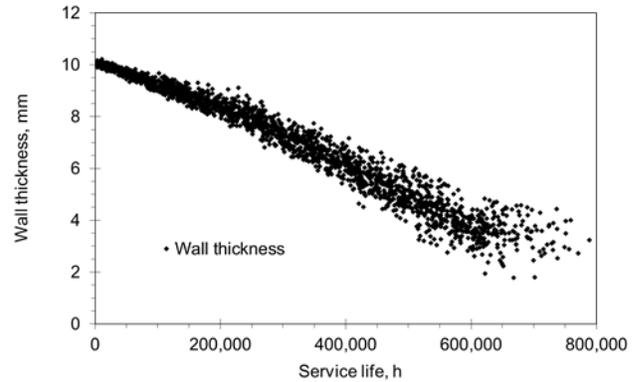
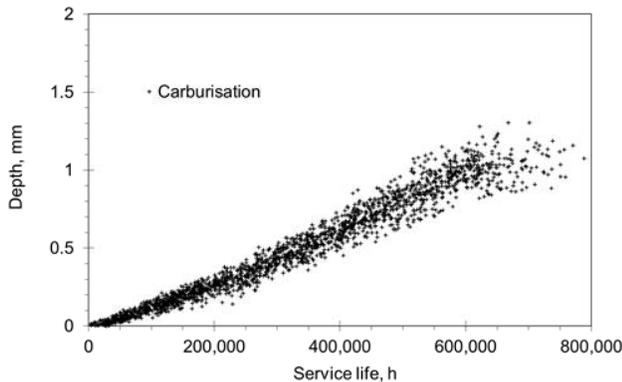
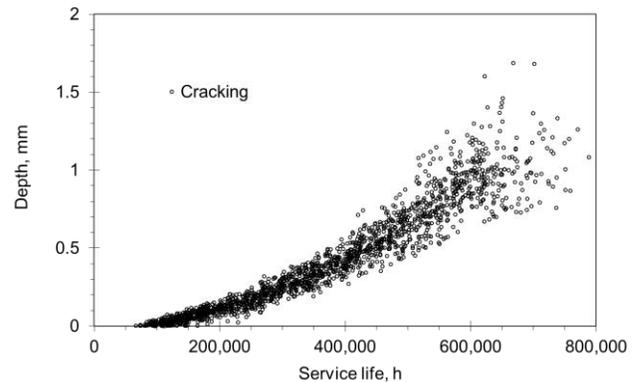
(b) Predicted fireside corrosion

(c) Predicted carburized zone thickness

(c) Predicted crack depth

Figures 8b, c, d show the predicted reduction in wall thickness and development of the carburized zone and associated cracking. Loss of section due to fireside corrosion is seen to be more significant than that due to cracking of the carburized zone. These graphs can be used as an immediate comparison against future inspection data. Any significant differences between prediction and observation will warrant investigation, as they will indicate either an error in the life prediction or some change in operational variables that needs to be accounted for.

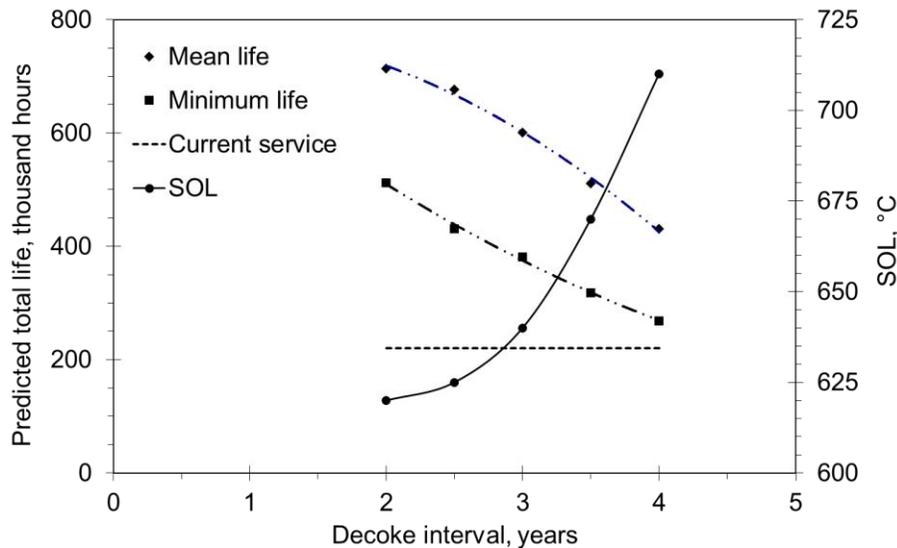
In this instance, the operator was satisfied with the finding that at least two further operating regimes were possible. However, in some cases there are reasons to consider the possibility of other options. An example is provided by another, similar, visbreaker. This unit was only achieving a 20% breaking efficiency and consideration was being given to improving its economic benefit to the refinery. A feature of visbreaker operation is the tendency for coke deposition on the tube walls, particularly in the area where cracking of the feedstock occurs. A consequence is that the tube wall temperature rises, since the coke acts as an insulator. When the temperature reaches the defined safe operating limit (SOL) it becomes necessary to shut the unit down for decoking, an expensive inconvenience. Under the then current regime, the SOL was set at 620°C and the decoking interval was two years. Two possibilities suggested themselves, both requiring the SOL to be raised. One was to raise the overall operating temperature so as to improve the breaking efficiency. Initial process calculations indicated that that would bring the product stream out of limits in terms of asphaltene content. The other possibility was to keep the start-of-run condition the same, but to increase run length by allowing a higher SOL. Accordingly, the life prediction package was set to simulate a range of possible run length / SOL combinations and determine their effect on tube life. Figure 9 shows the results obtained. Predicted remaining life at the then current operating condition was over 290,000h. Increasing the SOL to 640°C allowed the decoke interval to be increased to three years whilst reducing the remaining life to a still-useful 160,000h. This was adjudged the optimum solution and was adopted.

**Figure 9: Relationship between predicted life, decoke interval and SOL**

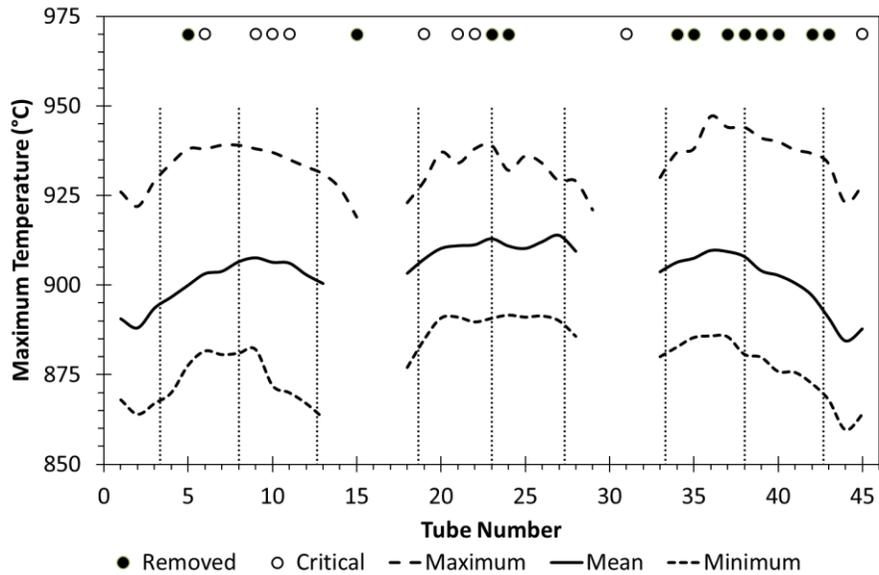
Figure 12 shows the thermal profile along the tube row, based on pyrometry measurements made over a six-month period. The maximum, mean and minimum temperatures are given for every tube that could be sighted. Vertical lines on the graph denote the burner positions – there are 6 rows of 9 burners on each side. The temperature distribution is most uneven, reflecting the irregular burner spacing, and shows distinct peaks and troughs. Regrettably, the same structural members of the firebox that force the irregular burner layout also preclude pyrometry of the tubes that are likely to be at the lowest temperatures.

Earlier in the unit's history several tubes were removed, and several others identified as critical, due to creep issues. Their locations are indicated on Figure 12 and it is seen that they are mostly associated with the higher temperature positions, as expected.

**Figure 12: Temperature variation along the SMR tube row – measured over 6 months**

By contrast, Tubes 43, 44 shown in Figures 10 and 11 are from the area where the lowest recorded temperatures occur. Given that the temperatures shown in Figure 12 come from within the firebox, but the tube outlets are located beneath the furnace floor and see no radiant heat, it is quite possible that the tube outlets come – at least intermittently – into the temperature range where metal dusting is possible. This would be rendered more likely if there is flow stagnation below the catalyst support basket which sits in the outlet casing or if there are any draughts below or through the furnace floor.
